PROJECT: Midnite Mine Remediation REPORT NO: 2021-17

OWNER: Newmont/Dawn Mining OPERATOR: Newmont/Dawn Mining

This weekly report provides a summary of Midnite Mine Site (Site) remediation action (RA) construction activities, quality assurance (CQA), quality control (CQC) and engineering activities for the period July 16 – 22, 2021. The Site activities discussed in this weekly report include, but are not limited to: Site Health, Safety, and Security; Community Liaison, Project Meetings, Regulatory Oversight, Site Visitors; Site Mobilization; RA Activities; Project Documentation; and Site Inspections.

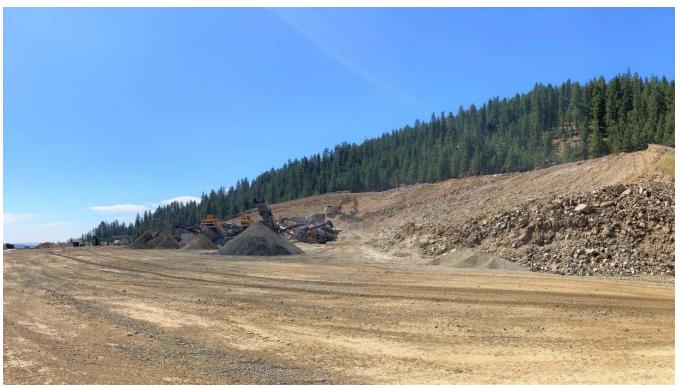
Figure 1 – Crushing and screening operations at the HSWRP, and progress on the HSWRP, view looking west.

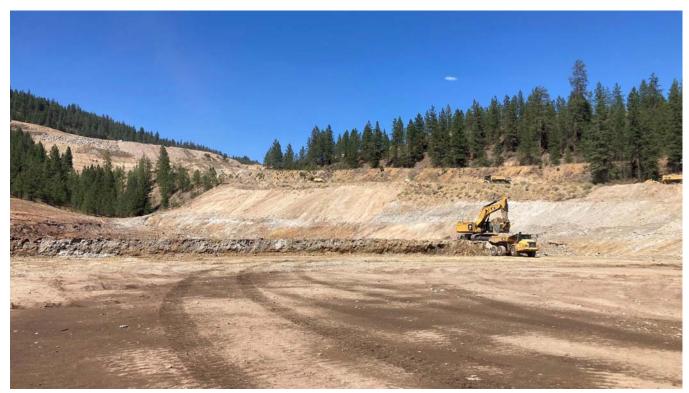
Figure 2 – Excavation, loading, and hauling of low activity/low reactivity material from the South Waste Rock Pile – Mid loadout 1, view looking northeast.

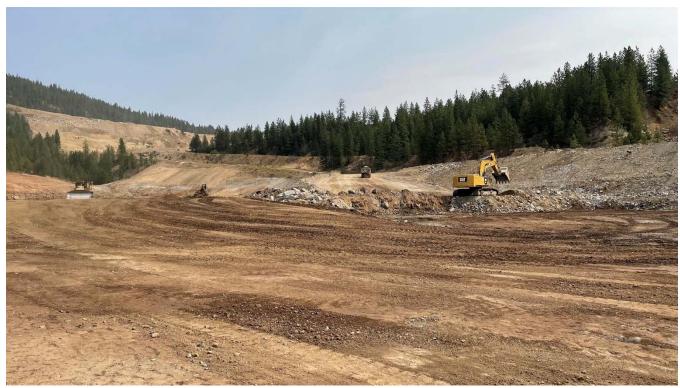
Figure 3 – Excavation, loading, and hauling of low activity/low reactivity material from the South Waste Rock Pile – Mid loadout 2, view looking southeast.

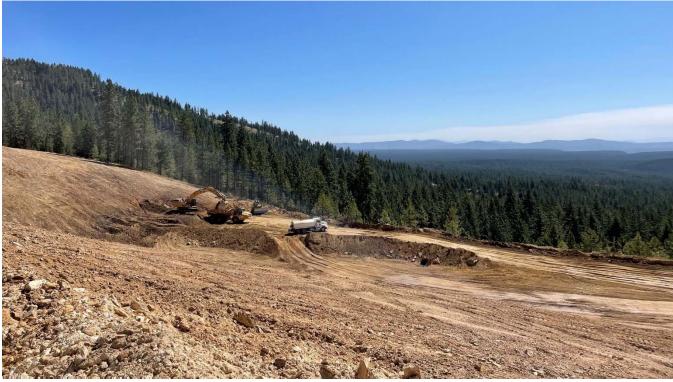
Figure 4 – Excavation, loading, and hauling of low activity/low reactivity material from the Pit 4 Overburden, view looking east.

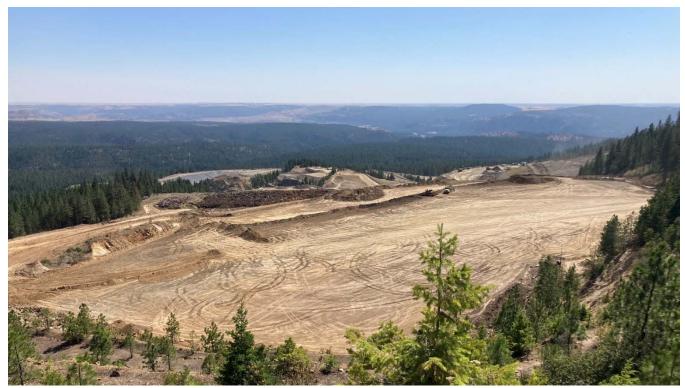
Figure 5 – Placement of low activity/low reactivity material in Pit 4, view looking south from the Pit 4 Overlook.

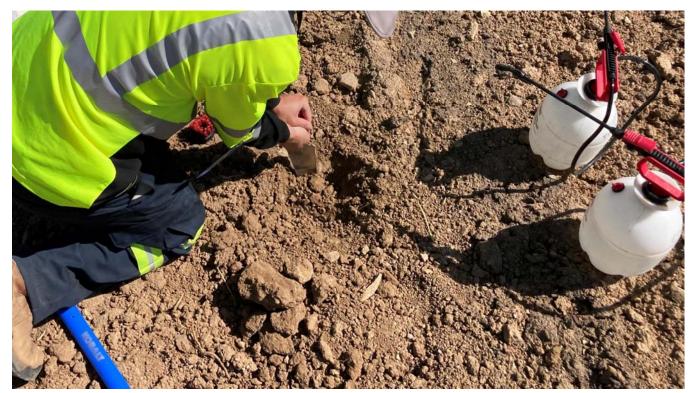
Figure 6 – Collection soil samples in the SCSZ for radiological analysis.

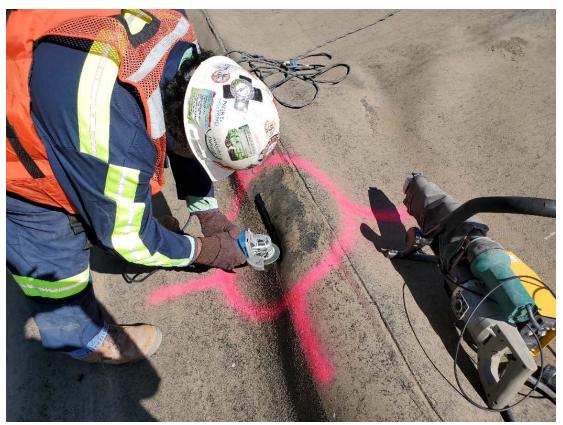
- Transferred water from the East Cell to the West Cell and noticed an increase in leakage levels. Currently leakage rates approximately 400 gallons per day / Action Leakage Rate 2. Coordinating for a leak detection service to identify leakage location.

Figure 7 – South Pond liner repairs – Northwest Linings technician abrading area to be welded

- Hi-Tech Rockfall scaled the walls of Pit 3 outside the areas protected by wire mesh drapery and attenuator systems.
- Northwest Linings repaired patches at 4 locations in the west cell of the South Pond where the patches were cut to allow trapped air to escape from under the patch.

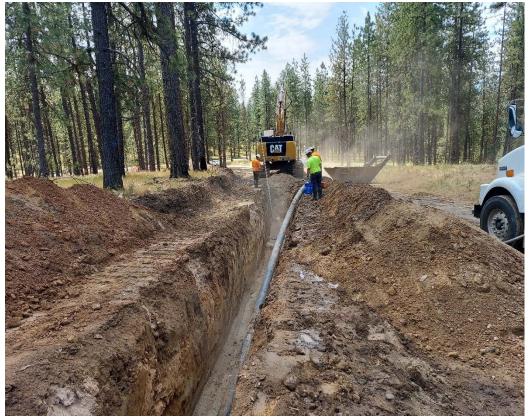
Figure 8 – Trenching and installation of Effluent Pipeline

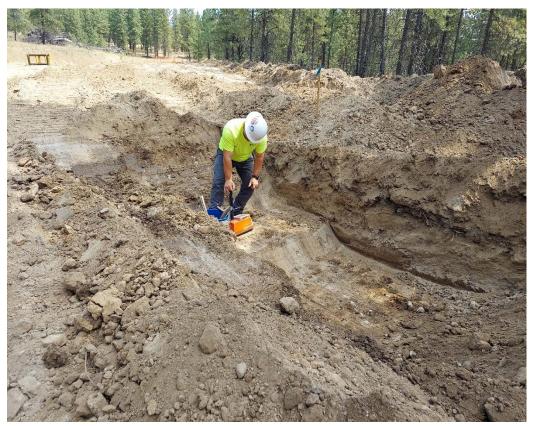
Figure 9 – Budinger and Associates technician taking density and moisture content readings of compacted trench backfill

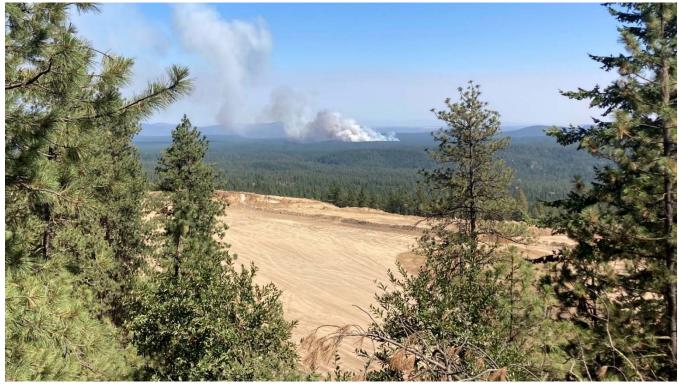
Figure 10 - View of the nearby Sherwood fire in the afternoon of 21 July, view looking southeast across Pit 4.
